# Manhole Inspection Summary

Manhole # S17II\_012MH

Insp Date: **6/12/07 8:48 AM**

**Location** Address: **1812 SMALLWOOD-BENTALOU**

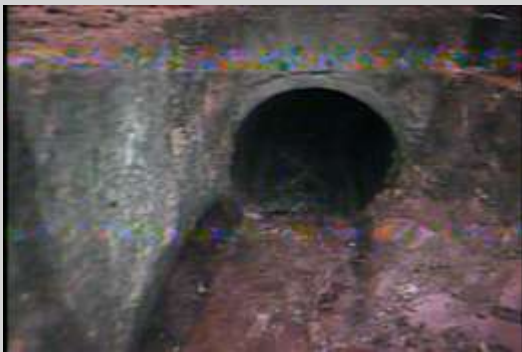
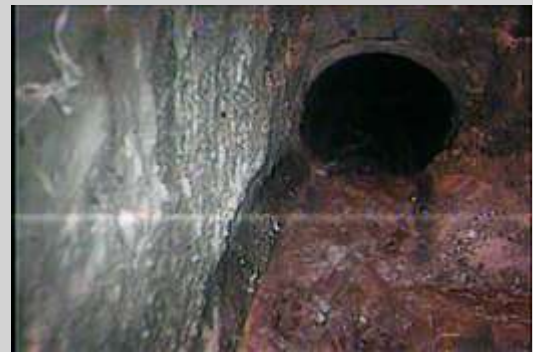
12 O'Clock Outflow

8 in. Circular Gravity Sewer  
Pipe Out @ 12 O'Clock

Pipe Height: **8.4** (in.) Rod and Bar (Angled)  
Pipe Material: **Clay** ☐ Pipe Lined  
Invert Depth: **10.44** (ft.) Flow Characteristics: **Slow**  
Deposits: ☒ None ☐ Mud ☐ Sludge ☐ Debris ☐ Grease  
Silt Depth: (in.) Deposits Extent:  
Infiltration: **None** Pipe Seal Cond: **Sound**

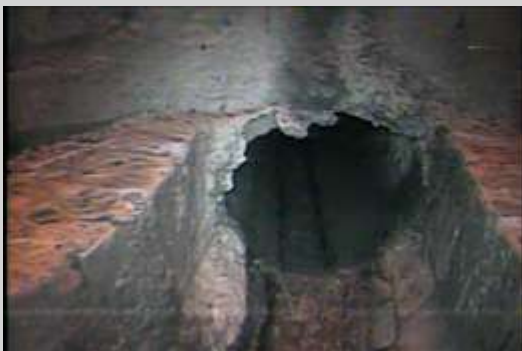
3 O'Clock Inflow

8 in. Circular Gravity Sewer  
Pipe In @ 3 O'Clock

Pipe Height: **7.2** (in.) Rod and Bar (Angled)  
Pipe Material: **Clay** ☐ Pipe Lined  
Invert Depth: **10.02** (ft.) Flow Characteristics: **Slow**  
Deposits: ☒ None ☐ Mud ☐ Sludge ☐ Debris ☐ Grease  
Silt Depth: (in.) Deposits Extent:  
Infiltration: **None** Pipe Seal Cond: **Sound**

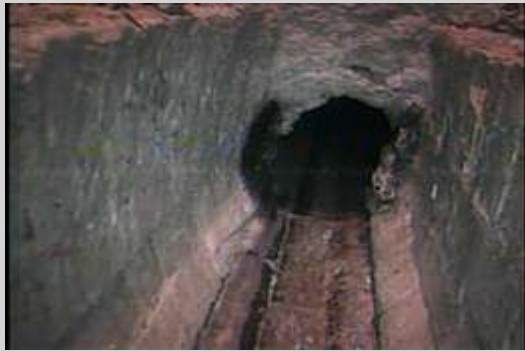
6 O'Clock Inflow

8 in. Circular Gravity Sewer

Pipe Height: **8.4** (in.) Rod and Bar (Angled)

Infiltration: **None** Pipe Seal Cond: **Sound**
